SUBJECT: Pioneer Sand Superfund Site
Five-Year Review

Superfund Five-Year Review Report

Pioneer Sand Site Escambia County, Florida

Prepared for
U.S. Environmental Protection Agency, Region IV
August 1999

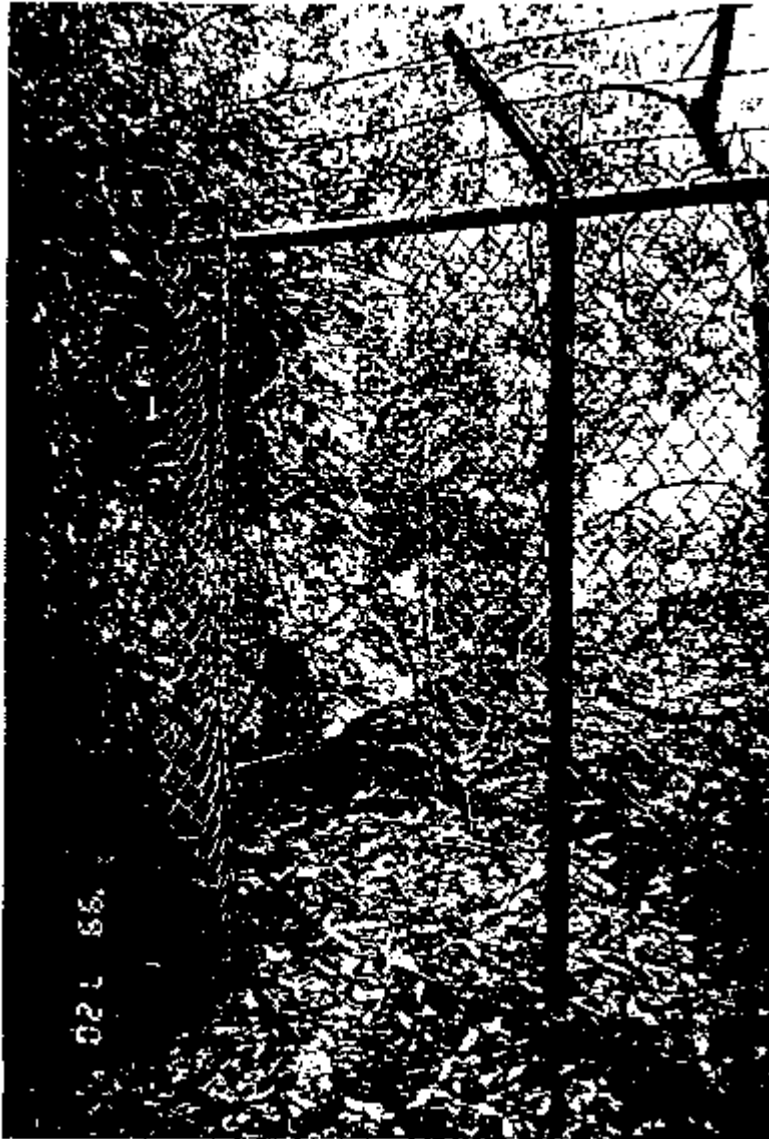
Other Site Features. Site access road was in good shape. Fence damage was noted on the north fence line. This damage was caused by trespassers gaining access to the site.

Hole Cut in Perimeter Fence by Trespassers

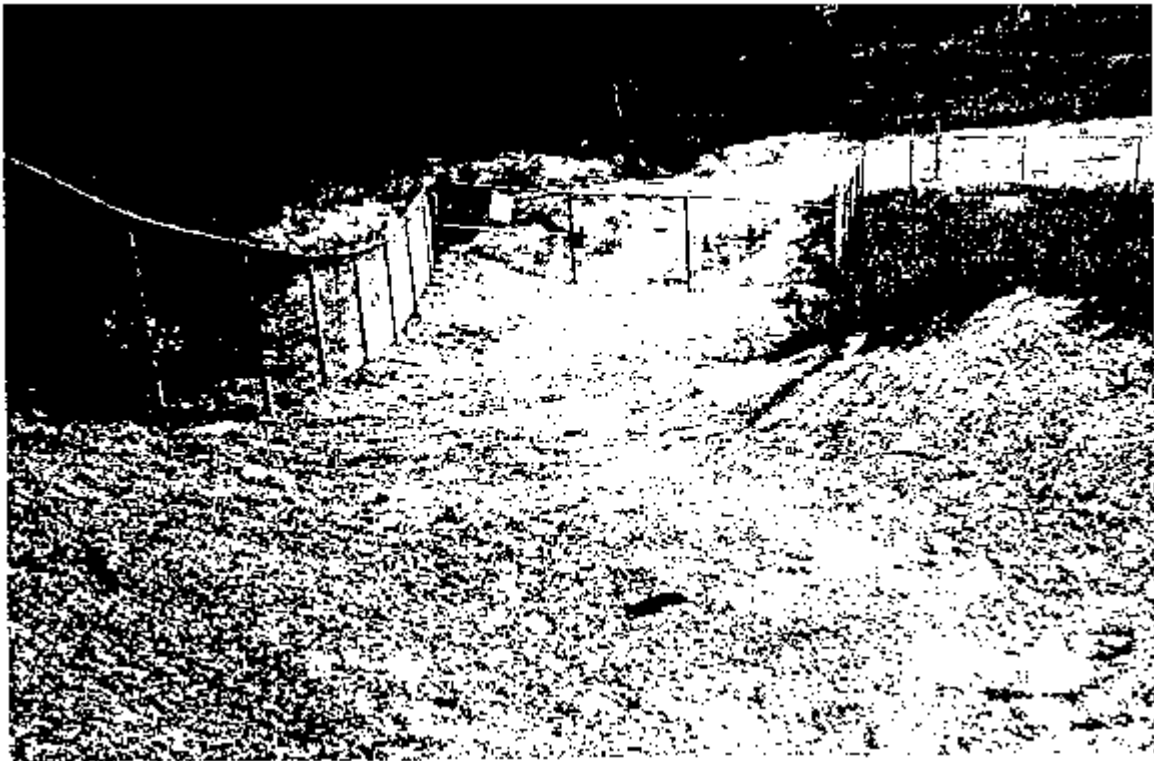
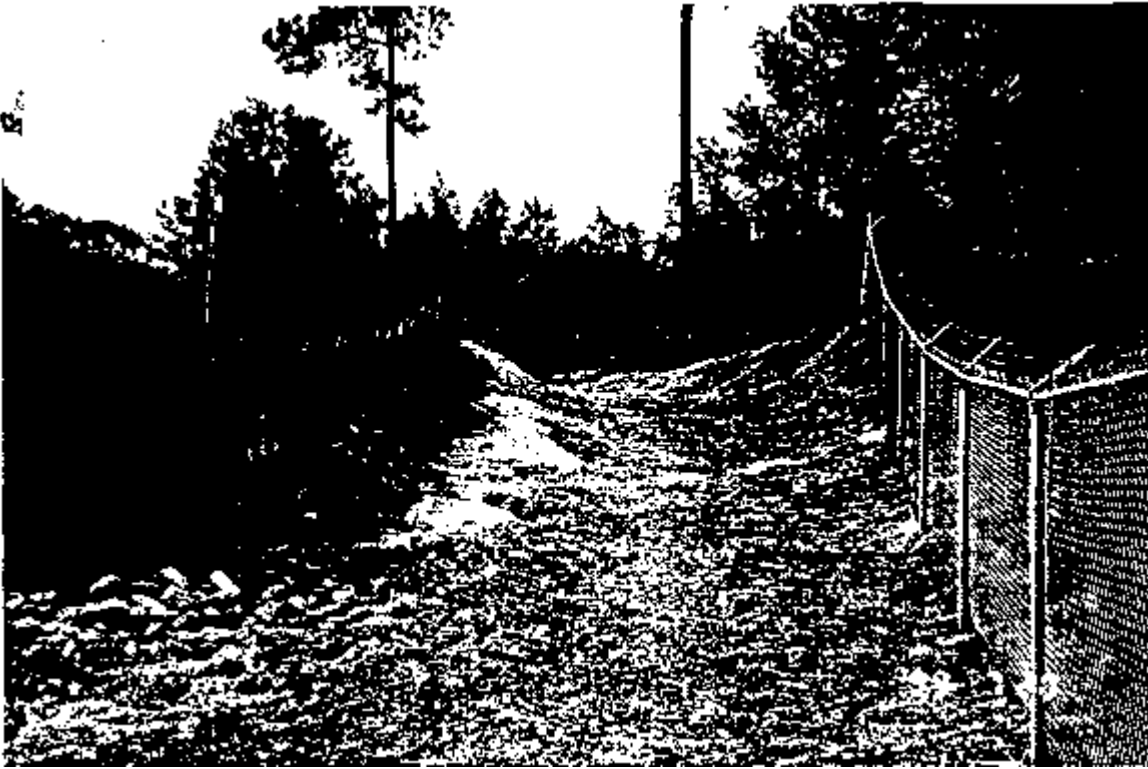
O&M costs are running approximately \$50,000 per year. This amount covers sampling and analysis from monitoring wells, visual observations in the leachate trench risers and vegetative cover maintenance. In April 1999 CSES incurred an additional cost of \$20,000 for erosion repairs.

Recent Erosion Repair Effort Located on North East Corner of Site
